# van der stahl®

## Criteria Board for Heat Sealed Closure Systems on Pre-formed Sterile Barriers

### REFERENCE CARD

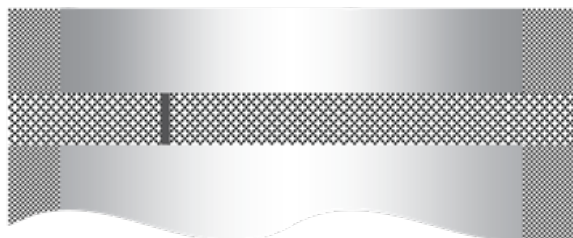
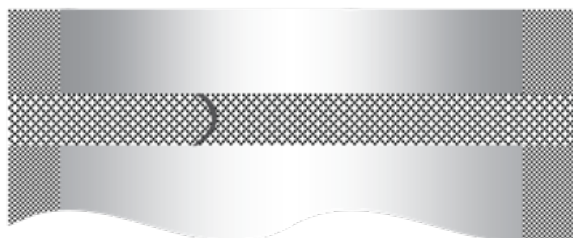
**1. CHANNEL:** A thin unsealed pathway across a seal width. The channel may appear within the seal in a variety of forms. The channel may allow leakage risking contamination.

The channel may be caused by a wide variety of conditions. Including a damaged platen. Pouch can be moved to different areas to identify damaged area on platen.

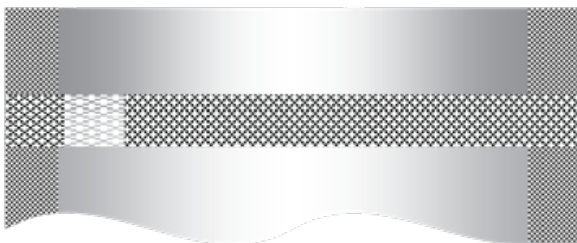
**2. UNSEALED AREA:** a wide unsealed area or gap on a pouch.

The seal may not have been made properly or ruptured after sealing from environmental forces on the package.

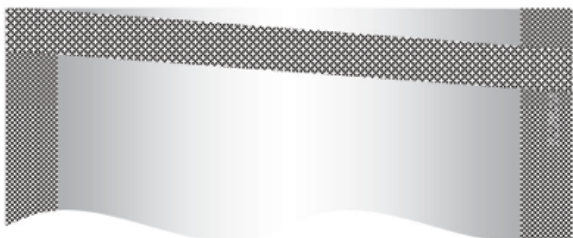
**3. CLOSE TO EDGE:** Seal is closer to edge than specified on one end or the entire length.

Pouch not positioned correctly while sealing, consider alignment guides for operators.

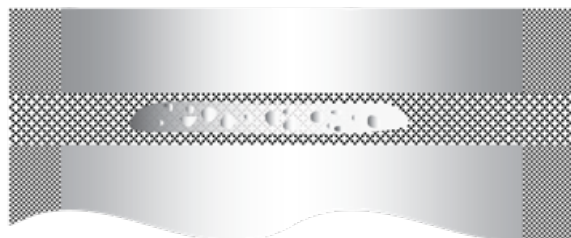
**4. OVER SEALED:** The seal surface may be rough, bubbly, cloudy, or appear burnt. The white Tyvek material appears transparent or translucent in the seal area.

A combination of too much heat, dwell time, or pressure during sealing.

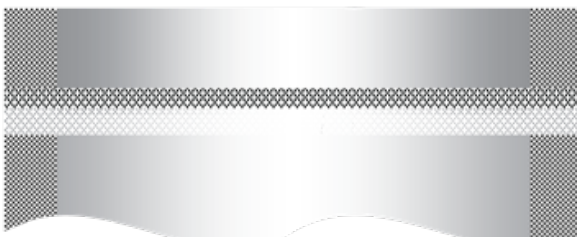
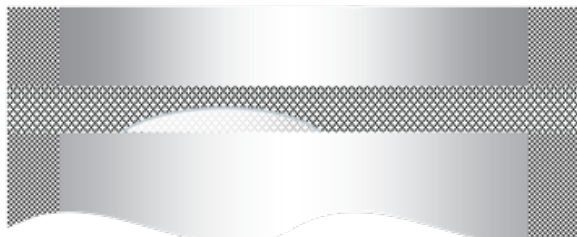
**5. NARROW SEAL:** The seal width is less than original minimum specification.

Seal creep or partial seal rupture on the seal surface due to environmental stresses, seal contamination, or sealer needs maintenance.

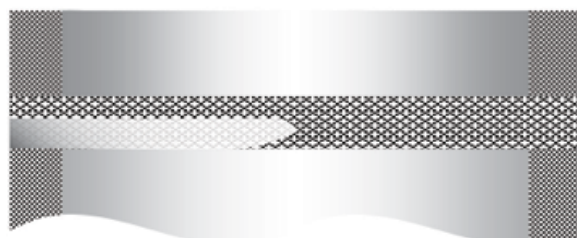
**6. UNDER SEALED:** A lifting of the material on part of the entire seal. Often appears as a lighter area on the seal surface

Possibly due to low platen pressure or low temperature during the sealing process or too short of a heat dwell.

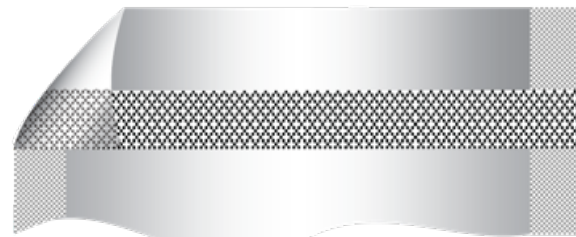
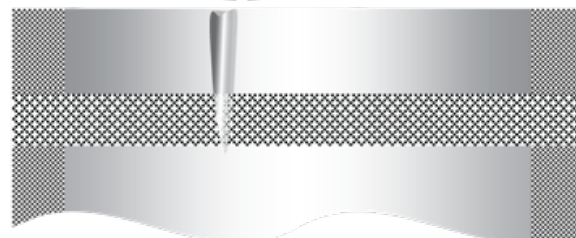
**7.FOLD OVER AND PLEATS:** The material folds over before sealing and is in the seal area.

The folded area could result in a channel or poor seal strength. The material could fold at an edge or in the center of a sealed area.

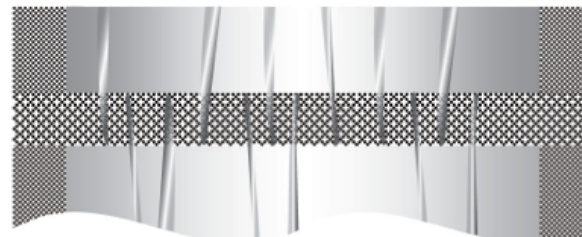
**8. SEVERE WRINKLES:** Creases puckering or wrinkling along seal edges that may interfere with the seal. Small or minor wrinkles along the seal are not defects

Severe puckers or wrinkles are often associated with too small a packaging system for the contents or inconsistent/improper handling during sealing. See notes on reverse side.

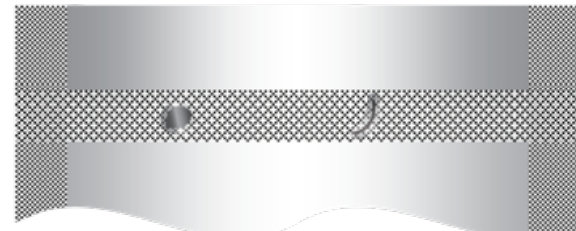
**9. FOREIGN MATERIAL:** Product or foreign debris embedded in the seal area. Note: View seal directly down and to the side of the viewing plate for best results.

Seal contamination during shipping, storage, or packing of the product before sealing.
