# SEAL CHANNEL

## Seal Channel

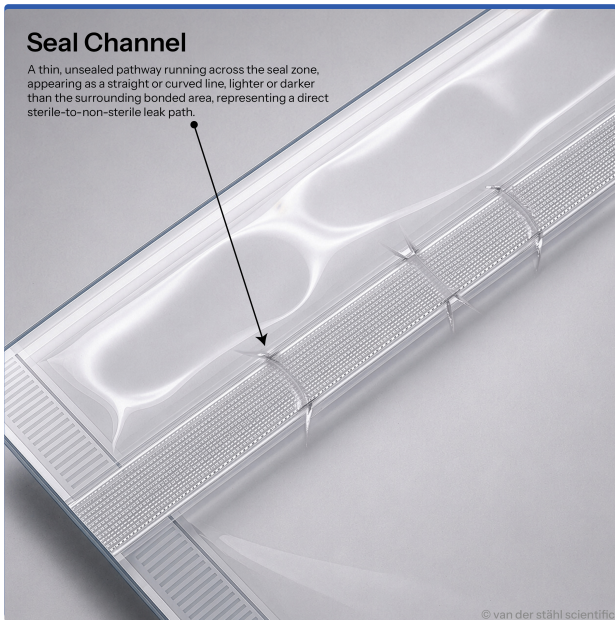
A thin, unsealed pathway running across the seal zone, appearing as a straight or curved line, lighter or darker than the surrounding bonded area, representing a direct sterile-to-non-sterile leak path.

A **seal channel** is a thin unsealed pathway across the width of the seal that may reach from the sterile to the non-sterile side of the pouch seal. The channel may appear within the seal in a variety of forms often presenting as a straight or curved thin line. Depending on the material the channel may present as a darker or a lighter colored line compared to the surrounding sealed area. The channel may indicate a direct leak pathway that may result in sterility loss and content contamination.

A second level of evaluation could provide deeper insight to this visual anomaly. Consider performing a dye penetration test (ASTM 1929) to determine if the channel represents a gross leak fault. The channel may be caused by a wide variety of conditions, including a damaged platen, a bent heating element or worn consumable parts such as Teflon sheets or tape. This may also be a result of foreign material on the sealing platen. Perform a visual inspection of the sealing platen as well as run your finger across the entire sealing die to feel for surface anomalies. Move your pouch to different areas of the platen and seal a pouch as you move across the sealing area to help identify the damaged area.

Also determine if the medical device inside of the pouch (i.e., a needle or cannula) could have inadvertently been caught in the sealing jaws during packaging. We would also recommend that you revisit your DOE (design of experiment) to determine if you are at nominal settings for temperature, heat contact dwell, cool down dwell and force based on your pouch material. We would also recommend performing a high-level service and/or repair on the sealing machine by replacing all consumable parts connected to the sealing area. If it was determined that the pouch content entered the sealing zone, consider additional operator training or machine guards that will prevent your device from entering the sealing environment to prevent contact damage to the sealing platen.
